**LARCHMONT WATER COMPANY
DAM NO 2**

**WESTCHESTER COUNTY
NEW YORK**

INVENTORY NO 112

**PHASE I INSPECTION REPORT
NATIONAL DAM SAFETY PROGRAM**

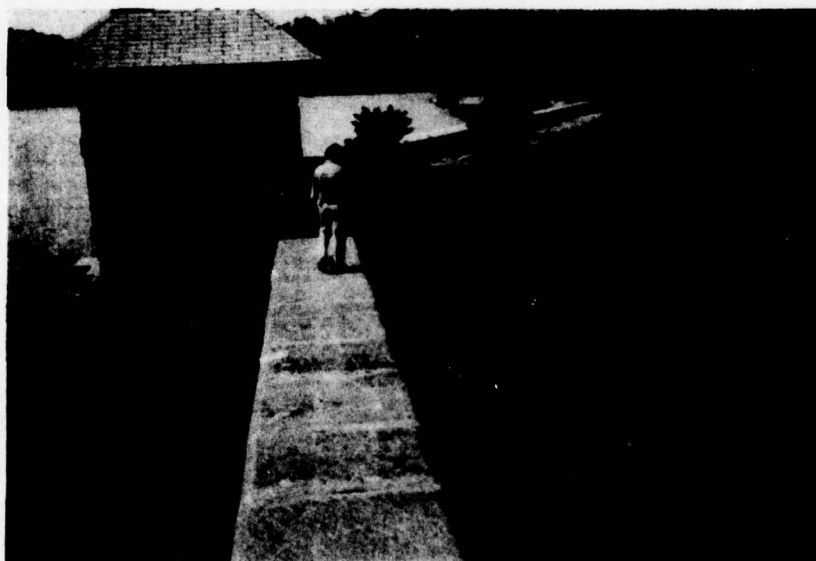
2. Closeup of spillway with concrete cap and masonry ogee section.

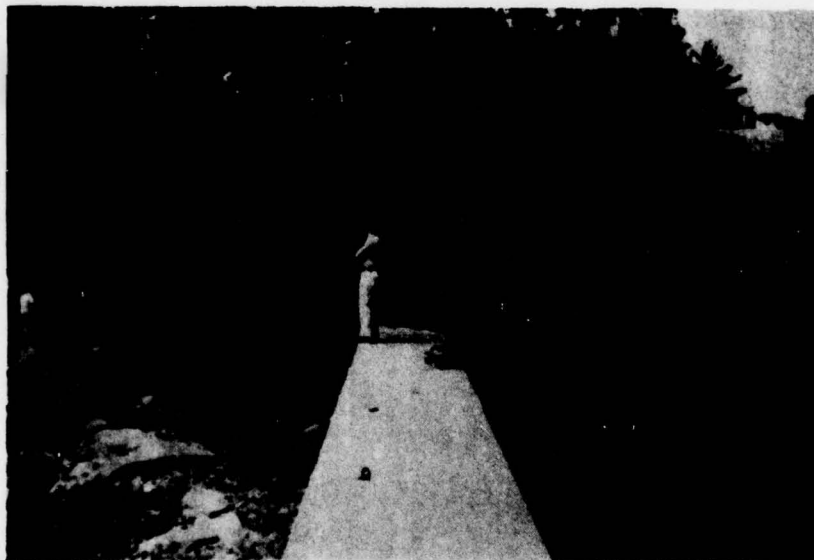
6. Closeup of east abutment.

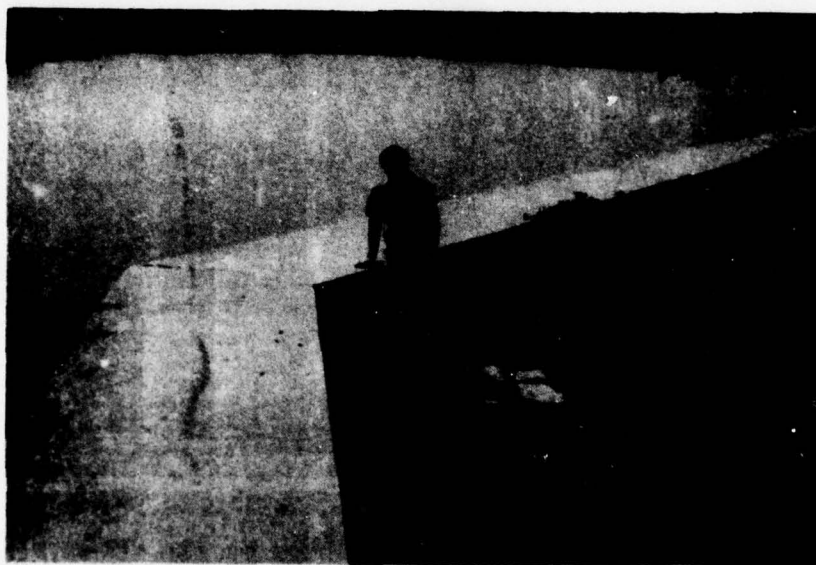
10. Closeup of top of dam showing concrete section on left modification and masonry section on right. Section in between filled with rock. This section has been vandalized, leaving a 2.0-foot hole.

A limited depth of rubble in the dam core between the upstream masonry facing and rock faced downstream slope in the vicinity adjacent to the spillway's southerly headwall has been removed, presumably by vandals. The condition has not yet had any significant structural effect.
